San Juan County Courthouse

Seismic Evaluation

REPORT

April 15, 2022
WJE No. 2019.5417

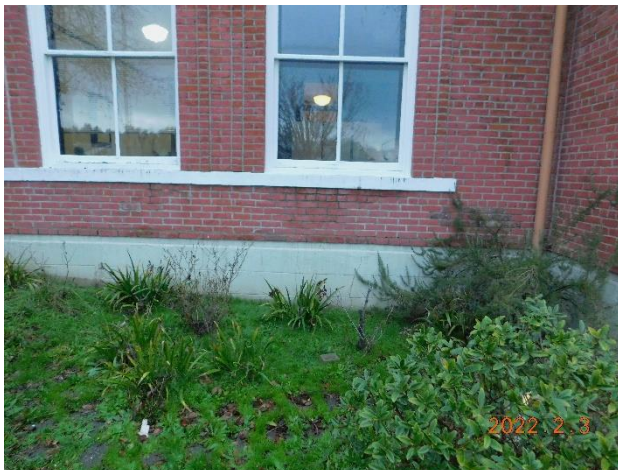
The exterior walls of the original courthouse building have experienced minor deterioration (Figure 15). Some areas of the mortar joints have been re-pointed; however, this re-pointing work has not matched the existing mortar (Figure 16).

Figure 15. Minor deterioration of exterior brick below the windows.

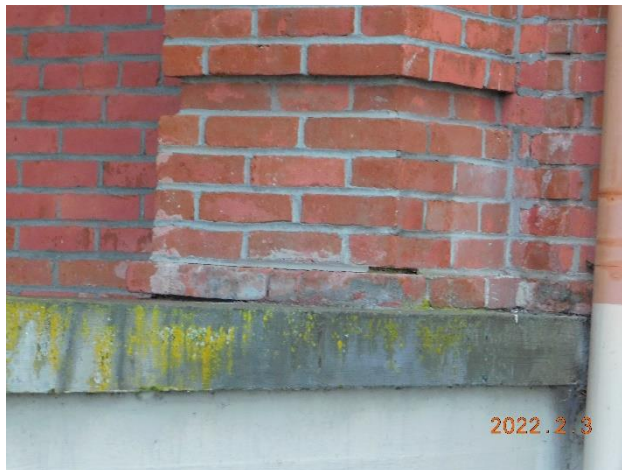
Figure 16. Poorly matched repointing of mortar joints.

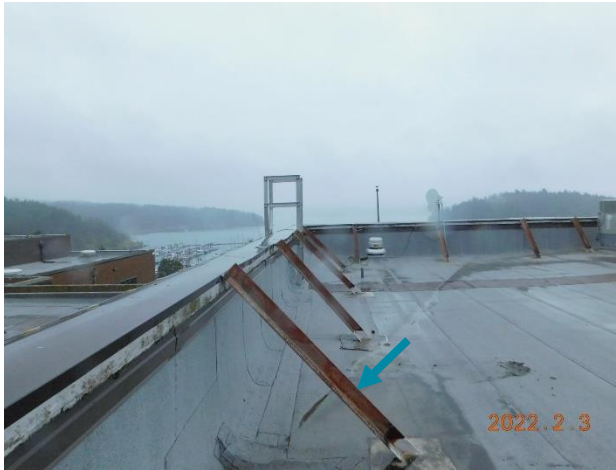
Figure 17. Steel angles (arrows) have been installed to brace the masonry parapet at all four sides.

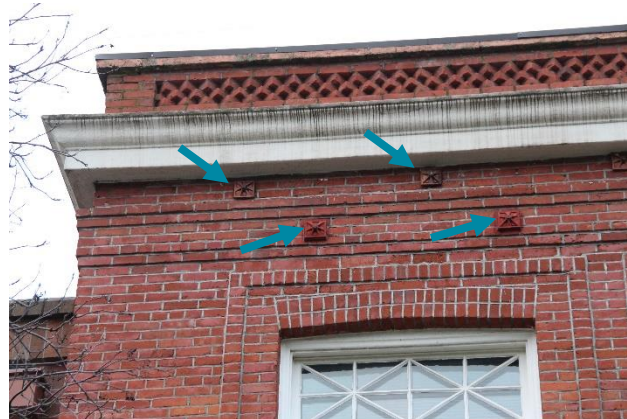
Steel plate "rosettes" were observed at the second floor and roof levels from three sides of the building exterior (Figure 18) with rosettes also visible at the roof level on the fourth side. Rosette plates are typically used to tie wood floor framing to masonry walls. However, the 1982 remodel drawings show the roof structure to be concrete. Due to the presence of hard ceiling finishes, the construction type of the roof could not be verified.

Figure 18. Steel rosette plates (arrows) at the west side of the Courthouse at the roof level.

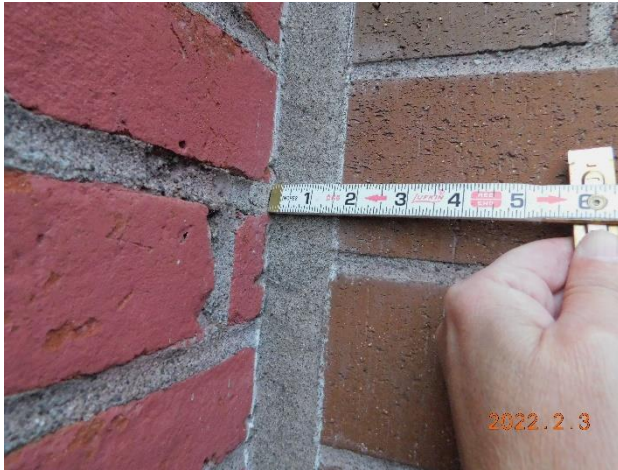
There is a 1-1/2 inch wide gap separating the Courthouse Expansion building from the Original Courthouse building (Figure 21). The gap is filled with mortar or similar cementitious material.

Figure 21. Mortar-filled gap between the original courthouse building and the 1980s expansion.

The original courthouse building, the 1980s expansion, the 1980s second story expansion, and the sheriff’s wing addition are all constructed with no apparent seismic joints separating the buildings. As a result, they are not compliant with the requirement for providing a gap of 1.5 percent of the building height between buildings. Because of the difference in construction of these buildings, their responses to seismic shaking will be different and they will have a tendency to pound against each other during an earthquake. This will likely result in damage to the nonstructural features that cross the gaps between the buildings.

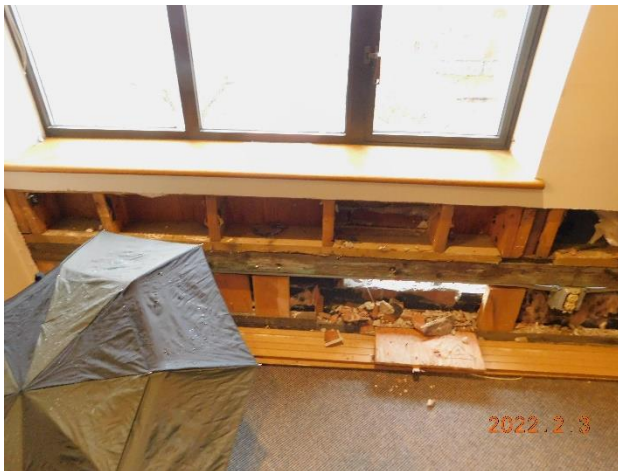
As part of a separate investigation, the County had created an investigation opening in the south wall between the first and second stories (Figure 24). The opening confirmed that the wall framing at the first story is reinforced brick masonry (vertical steel reinforcement spaced at 24 inches) and the wall framing for the second story is light wood framing with brick veneer (Figure 25). A wood sill plate for the second story is attached to the reinforced brick masonry wall with expansion anchors.

Figure 24. Interior view of the investigation opening on the south wall of the Courthouse Expansion at the interface between the 1980 first level and 1984 second level.

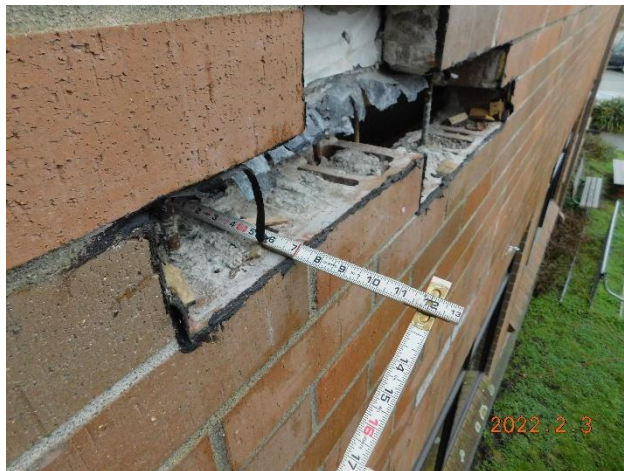
Figure 25. Exterior view of the investigation opening on the south wall of the Courthouse Expansion at the interface between the 1980 first level and 1984 second level.

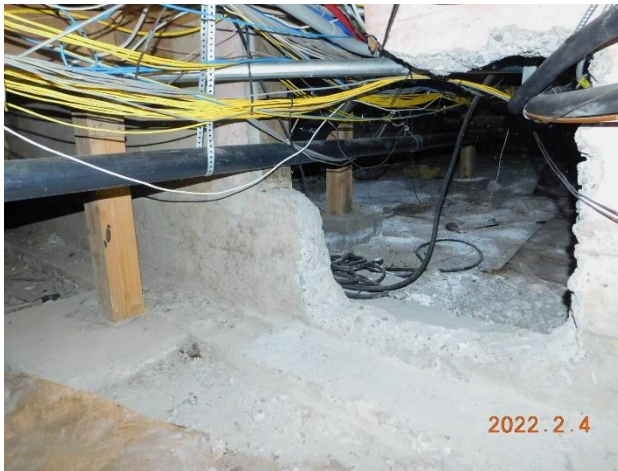
Figure 28. Existing opening previously chipped in the concrete stem wall in the crawl space reveals no reinforcing bars present.

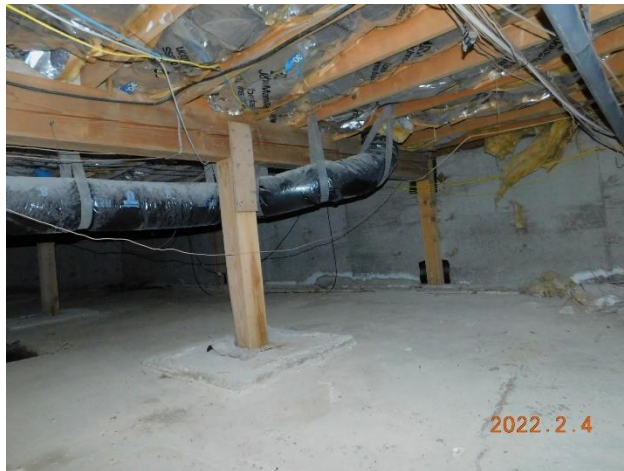
The buildings walls are light frame wood and CMU. Exterior wood-framed walls are sheathed with plywood siding. CMU wall locations are shown in Figure 9. The exterior walls and CMU walls are supported by concrete stem walls and strip footings at the foundation. The entire building is elevated above a crawl space. WJE observed 1/2-inch diameter anchor bolts at 48 inch spacing connecting the exterior wall sill plates to the concrete stem walls. Concrete stem walls at the interior of the building are unreinforced (Figure 28). The first floor is wood framed with 2x8 and 2x10 joists spanning between wood beams and/or the concrete stem walls. Wood beams are supported by 6x6 wood posts with concrete footings. The wood beams are typically connected to the posts with nailed plywood gussets (Figure 29), however in some cases, the beam just bears directly on the post with no side plates or steel connectors, or in other cases, a gusset is present on only one side of the connection. There are typically no mechanical connectors attaching the posts to the footings (Figure 29).

Figure 29. Posts supporting the first floor framing bear on concrete footings with no mechanical connection to the footing. Plywood gussets can be seen connecting the beams to the wood post (arrow).

The girders supporting the first floor framing were observed to not have direct positive connections using plates, connection hardware, or straps between the girder and the column support as required by the Tier 1 screening procedure. There is also no positive connection between the bases of the posts to the foundations.

We identified several deficiencies and several unknown conditions that are likely deficient. Within the crawl space, we recommend that all of the wood posts have new steel post bases and post caps installed. A conceptual detail for the post base retrofit is shown in Figure 38 and a conceptual detail for the retrofit post cap connecting the posts to the beams is shown in Figure 39. In addition, new anchor bolts connecting the sill plates in the crawl space to the underlying footings should be installed, and selected portions of the wood-framed cripple walls should be sheathed with plywood. Further analysis may be required to address load path discontinuities presented by the vertically discontinuous high roof north wall, but possible retrofit solutions may include addition of sheathed stud walls, wood blocking, and concrete footing below the high roof north wall.

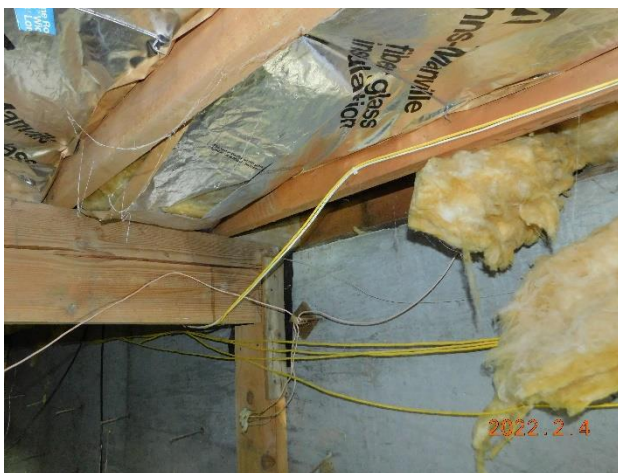
Figure 30. Beam supporting first floor framing for the west side of the building not attached to the interior concrete stem wall.

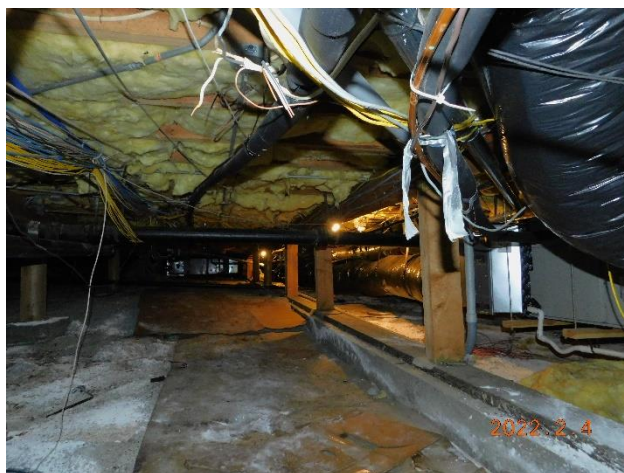
Figure 31. Interior wood-framed cripple wall in the crawl space without sheathing and without anchors into the concrete.

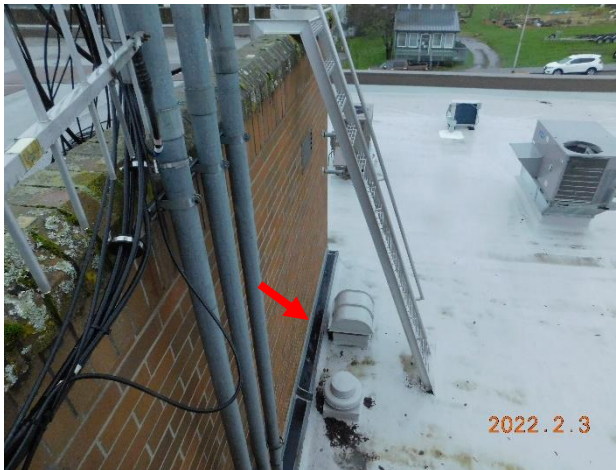
It should be noted however, that the common deficiency related to the lack of a separation joint also applies to this building. The drawings show that the building was to be constructed with a 2-inch gap between the Sheriff's Wing and the 1980s Courthouse Addition. This gap is slightly deficient compared with the ASCE 41 criteria, which requires a gap of 1.5 percent. For a 12-foot story height, the required gap is 2.16 inches. An expansion joint appears to exist at the roof level (Figure 32) and along the exterior walls (Figure 33). The width of the gap should be confirmed.

Figure 32. Horizontal expansion joint between the roof of the Sheriff's Wing and the exterior wall of the 1980s Courthouse Addition.

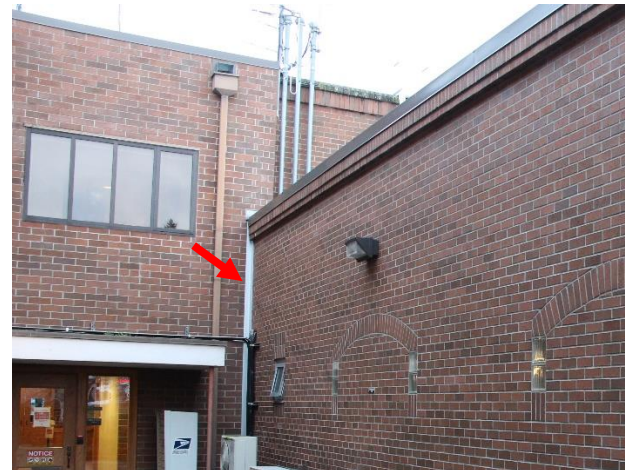
Figure 33. Vertical expansion joint between the exterior wall of the Sheriff's Wing and the exterior wall of the 1980s Courthouse Addition.

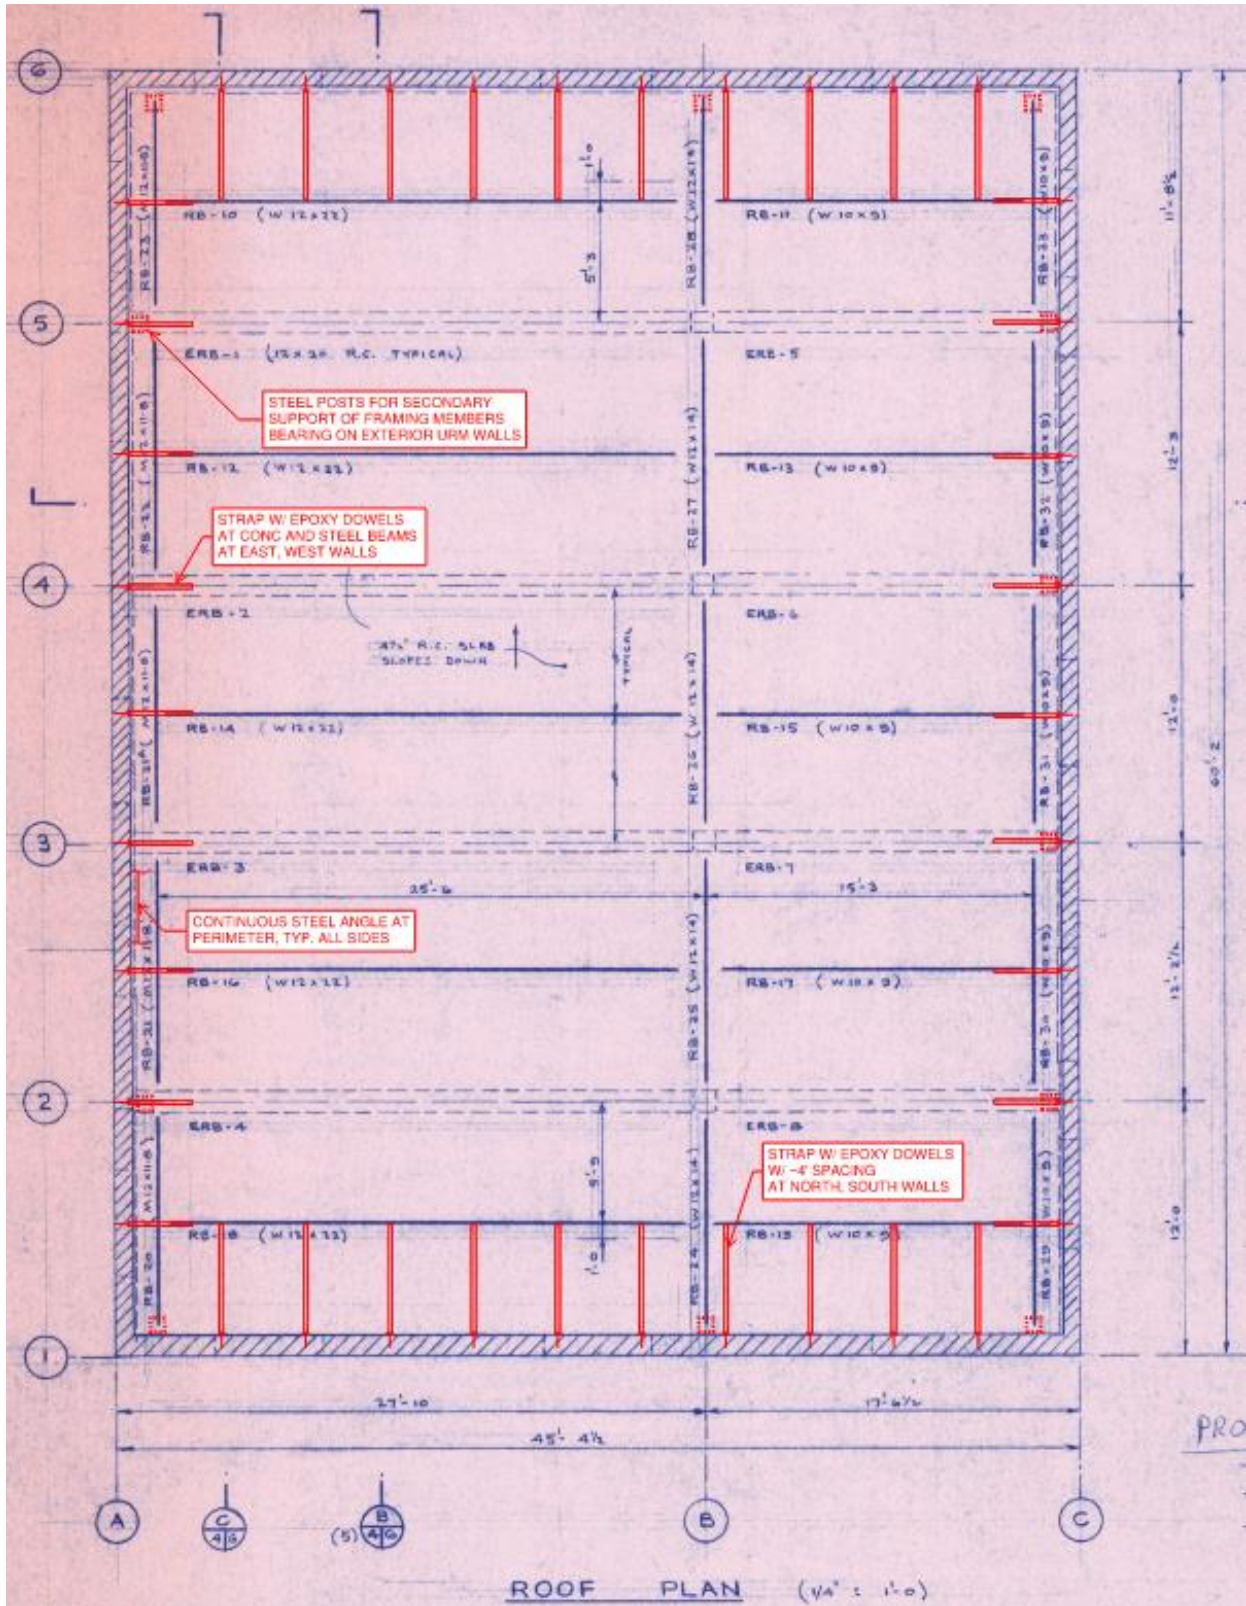
Figure 34. Courthouse Roof Plan from Sheet S-4 of the 1982 courthouse remodel drawings. WJE annotations are shown in red describing proposed conceptual retrofit options to address seismic deficiencies identified.

The second level walls have height-to-thickness ratios which exceed the recommended limit which suggests potential for out-of-plane deformation of walls due to seismic forces. To address this vulnerability, vertical steel "strongbacks" can be installed between windows to stiffen and strengthen the walls out-of-plane. "Strongback" steel elements should be tied to the wall with steel anchors epoxied into the existing brick as well as anchored to the second level and roof diaphragms. The required spacing of strongbacks will depend on the strength and stiffness of steel elements used.

Because the connection of diaphragms to walls is unknown and likely deficient, diaphragm-to-wall connections should be enhanced. Lateral forces can be transferred from the concrete diaphragms to the brick masonry walls via steel elements, such as an angle, along the perimeter of the building interior. The steel elements should be anchored to both the concrete diaphragms and brick masonry walls with regularly spaced fasteners, the size and spacing of which would be determined by further analysis. Out-of-plane forces can be resisted with new steel straps on the roof anchored and placed perpendicular to the brick masonry walls. The steel straps would be spaced approximately four to six feet on center around the perimeter of the roof and would be attached to the walls and roof with steel fasteners.

to walls may cause stress concentrations within the diaphragm and prevent the exterior walls from being braced continuously. To address this deficiency a horizontal structural element, such as a steel channel or concrete beam, can be installed along the wall at the stairwell and connected to the diaphragm at the north and south end of the opening. The structural element should be anchored to the diaphragm and to the brick masonry walls with regularly spaced fasteners.

Concrete and steel beams at the roof and second level bear on the unreinforced masonry walls at the perimeter of the building with no independent secondary support which is considered a deficiency. The intent of this provision is to provide alternate load paths for gravity loads should there be localized failure of the wall. To address this deficiency, steel posts can be installed below concrete and steel beams at the perimeter of the building below the roof and second floor framing. Installation of steel posts should continue to the building foundation and may need to be embedded within the first level walls to sufficiently support the floor and roof framing.

The proposed locations of these conceptual retrofit components described above is presented in Figure 34 and Figure 35.

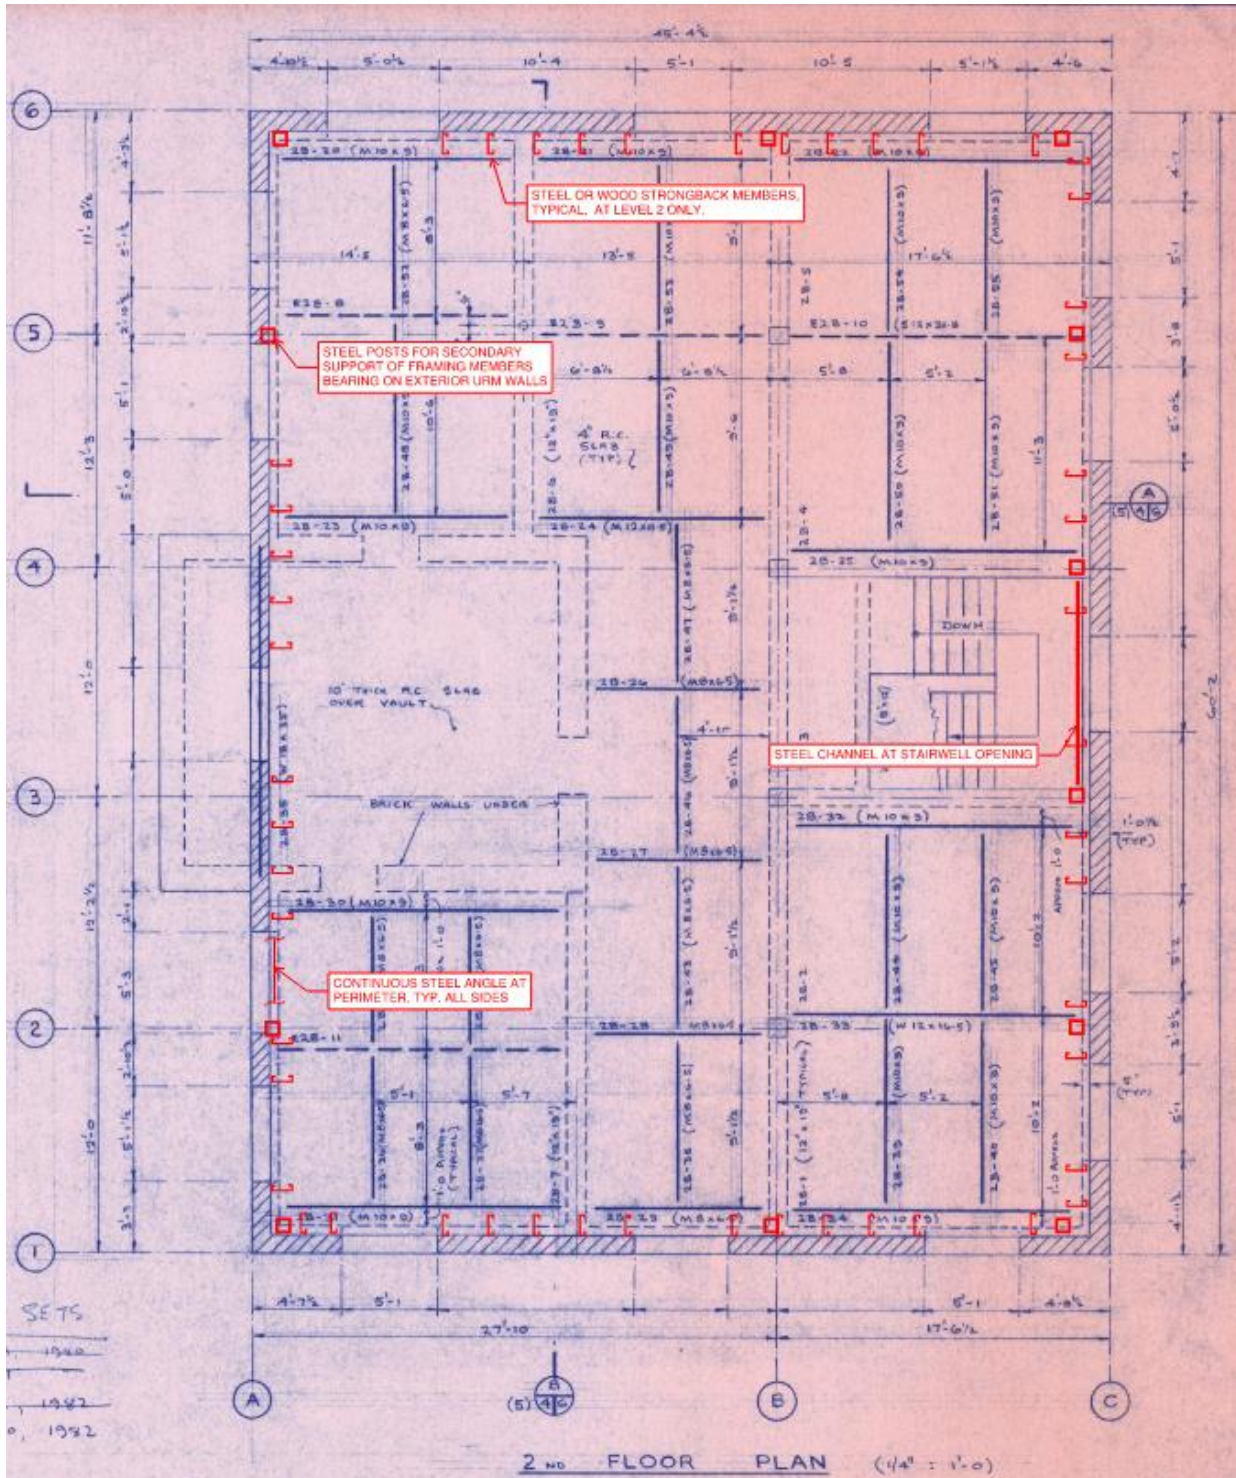
Figure 35. Courthouse Second Floor Plan from Sheet S-4 of the 1982 courthouse remodel drawings. WJE annotations are shown in red describing proposed conceptual retrofit options to address seismic deficiencies identified.
