# SHORELINE INVENTORY AND CHARACTERIZATION REPORT

## San Juan County

San Juan County Community Development and Planning Department

~~January Draft~~ April 2013-Final

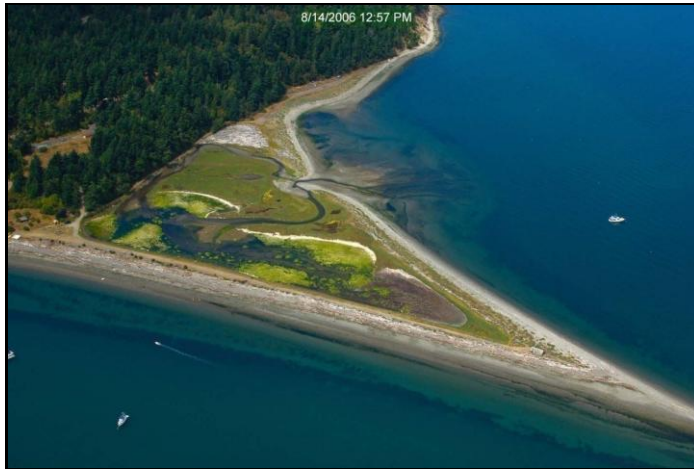
**Figure 3. Barrier beach along Spencer Spit, Lopez Island**

Barrier beaches – Barrier beaches are typified by a beach berm backed (landward of) a flat low backshore. Barrier beaches can be depositional or erosional, but are more typically a region of active transport between erosional and depositional areas. Their occurrence is sporadic throughout the County because they require a transport corridor, which is rare in bedrock-dominated areas. Where they occur, barrier beaches are armored more frequently than shorelines as a whole, possibly because as transport corridors they are prone to variability (erosion) over time. Figure 3 provides an example of a barrier beach along Spencer Spit on Lopez Island.

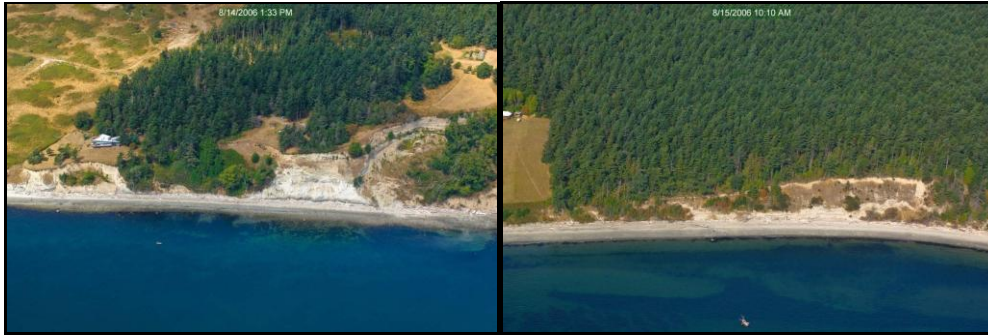
**Figure 4. Bluff backed beaches along Decatur and Waldron Islands**

Bluff backed beach – Bluff backed beaches are those shorelines where a beach exists at the base of a sediment-rich bluff. Bluff backed beaches can occur in front of feeder bluffs, but not necessarily. Bluff backed beaches are most often found in areas with copious amounts of glacial sediment, like Lopez Island. Bluff backed beaches are armored by approximately the same amount as shorelines as a whole, with a few prominent exceptions such as the North Coast Eastsound Management Area and on Shaw Island, where armoring is more extensive. Figure 4 provides examples of bluff backed beaches along Decatur and Waldron Islands.

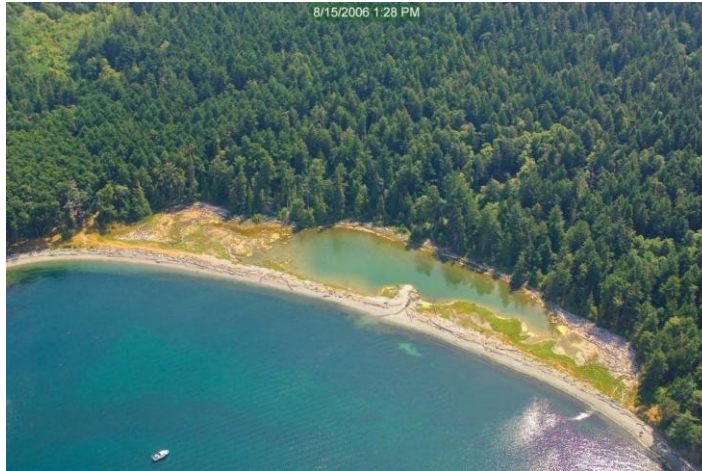
**Figure 5. Pocket estuary like shoreline along Third Beach, San Juan Island**

Pocket estuary like – This generic category refers to shorelines that are typically protected embayments that have a source of freshwater and marshes associated with them. This shore type is distributed throughout the County, though a few areas lack them entirely. Pocket estuary like shorelines are armored more often than shorelines as a whole, typically because they are often developed as low-lying areas with easy access to the ocean. Figure 5 provides an example of a pocket estuary like shoreline with a barrier beach along Third Beach on San Juan Island.

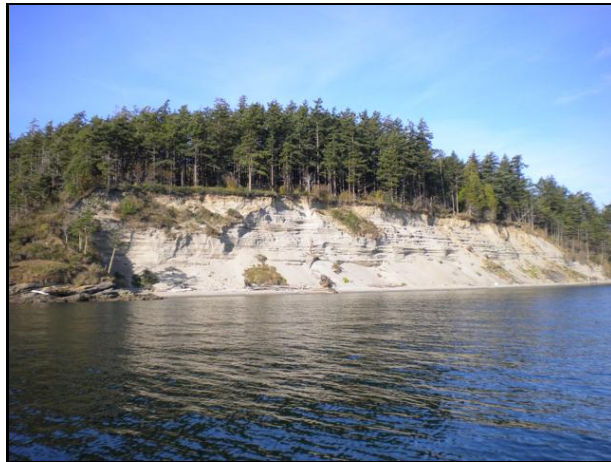
**Figure 7. Feeder bluff along Waldron Island**

Feeder bluff – A feeder bluff is an eroding bluff that supplies a significant portion of the sediment transported ~~shoreline~~ downdrift from it along the shoreline. Typically feeder bluffs in San Juan County are comprised of glacially derived sediments, and are most common on Lopez Island. Feeder bluffs are armored ~~aby~~ approximately the same amount as shorelines as a whole, with a few prominent exceptions such as the North Coast Eastsound Management Area, where armoring is more extensive. Figure 7 provides an example of a feeder bluff along Waldron Island.

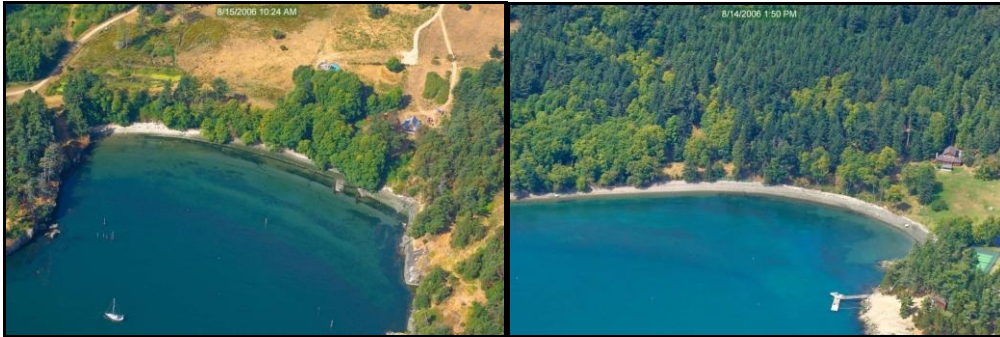
**Figure 8.** Pocket beaches along Waldron and Blakely Islands

Pocket beach - A pocket beach is a small beach that is contained between two bedrock headlands that exhibits little to no net longshore transport (Shipman 2008). Transport can be significant in a cross-shore sense. Pocket beaches are typically found in association with rocky shorelines, though not exclusively. They are armored slightly more frequently than shorelines as a whole. Figure 8 provides examples of pocket beaches along Waldron and Blakely Islands.

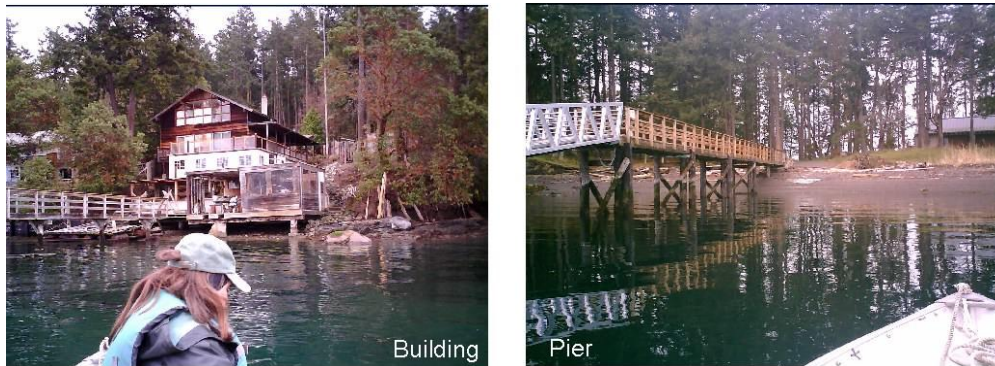
**Figure 9. Examples of Overwater Structures in San Juan County.**

Overwater structures in the County include bridges, buildings, large floats, piers or docks (see Figure 9) and an assortment of unusual features such as fill placed on a dock. There are a total of 655 structures per the available GIS inventory. Of the 655 structures, there are 6 bridges, 10 buildings, 51 floats, 544 piers/docks, and 44 unusual structures (Table 4.2.13).

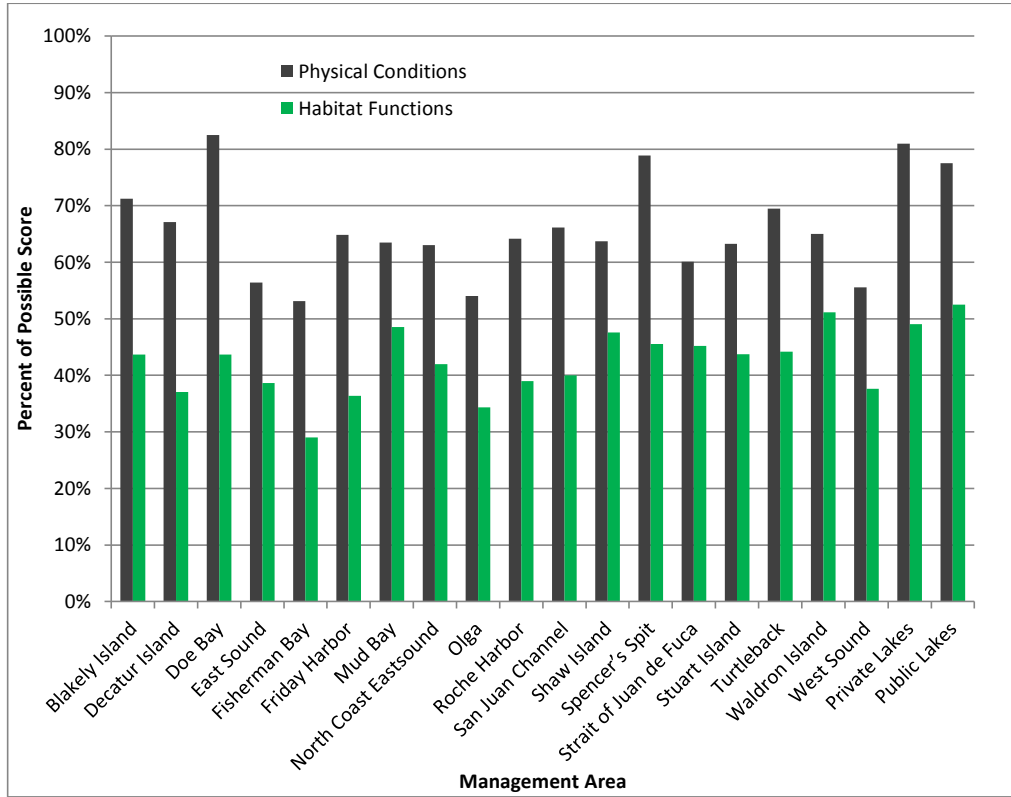
Figure 11. Summary of Physical ~~Conditions and~~ and Habitat ~~Conditions~~ Functions Found Within Each Management Area (percent of possible score).

Figure 11 shows the highest scoring marine management areas, for physical conditions are Doe Bay followed by Spencer Spit; Blakely Island and Turtleback also score comparatively high. Both the Private lakes and Public Lakes management areas score high for physical conditions and for habitat functions, ranking greater than 90 percent of the possible score for physical conditions, are Blakely Island, Doe Bay, San Juan Channel and Turtleback. The lowest ranking management areas for physical conditions are East Sound and Fisherman Bay and Olga management areas. Overall, physical conditions in all the majority of management areas score above 70-60 percent and with only four-four out of the 20 scoring less than 80-60 percent of the possible score. This suggests that, although there are reaches with substantial shoreline modifications, comparatively, the County as a whole provides important intact physical conditions to support nearshore and marine functions.

~~By far, the~~ The highest scoring marine habitat conditions were found in the [Waldron \(51 percent\)](#), [Mud Bay \(49 percent\)](#), and [Shaw Island \(48 percent\)](#) management areas ~~with a score of 78 percent followed by the Turtleback and Waldron Island management areas with 63 percent each.~~ It is important to ~~remind the reader note~~ that some of the WDFW PHS data sets used are based upon very few observations. Consequently, low species presence or habitat scores could be an artifact of the number of observations. This likely means that presence and habitat for some species is underreported and habitat functions for many management areas may, in reality, be higher than shown in the assessment, [especially in more remote areas and uninhabited islands](#). See *Section 2.4 Method Used to Inventory and Characterize Management Areas* for additional information on this important data limitation. The figure also indicates that more ~~intensively~~ developed ~~management areas~~ reaches (such as [parts of the East Sound Fisherman Bay](#) and [parts of the Olga management areas](#)) generally have lower reach scores for habitat conditions than less ~~well~~ developed areas (such as [the Waldron Island and Turtleback-Mud Bay](#) management areas).

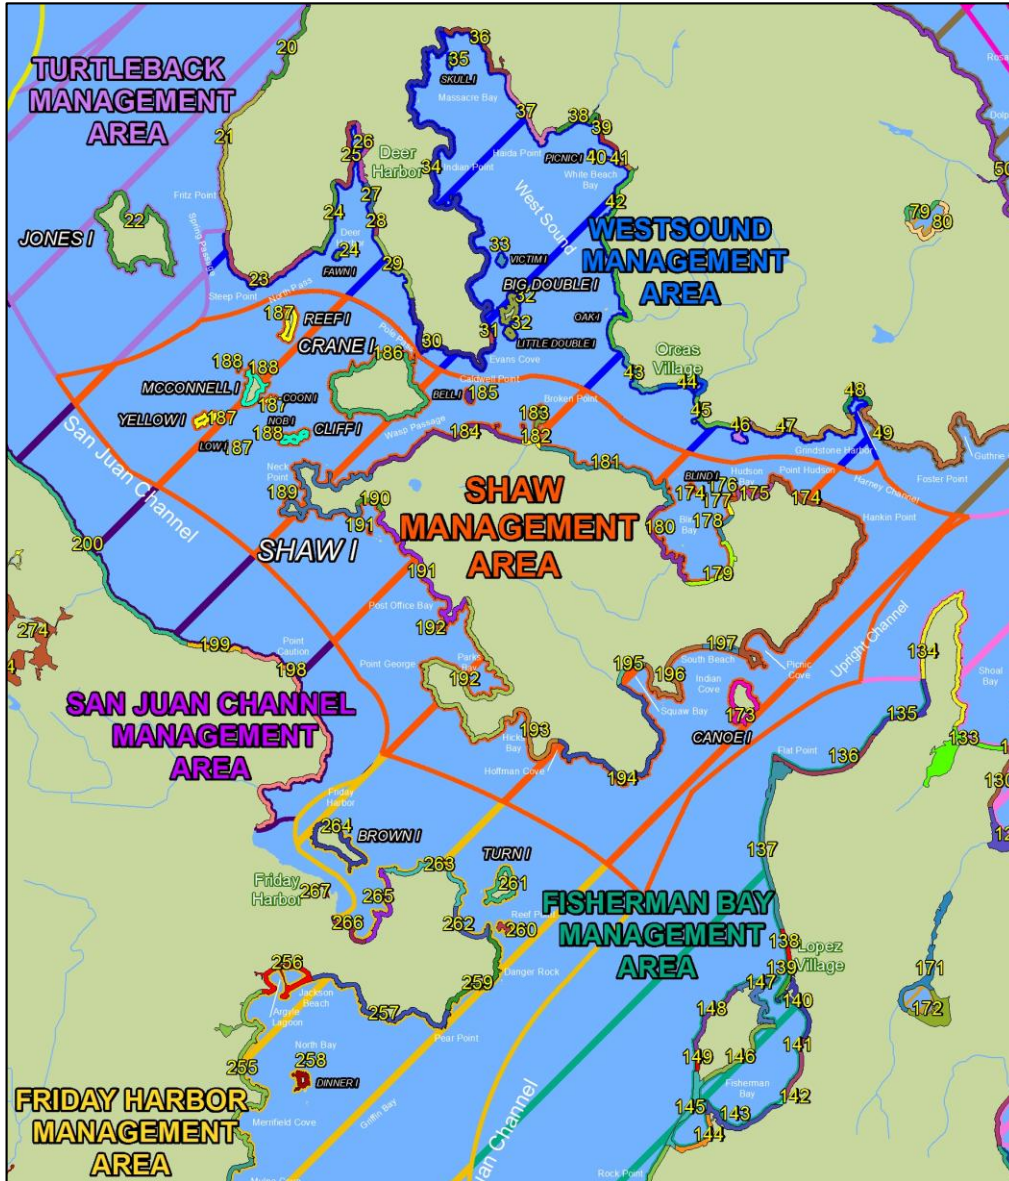
Figure 23. Shaw Island Management Area.

There are five small drift cells mapped in this management area. Two are isolated drift cells, which essentially are associated with large pocket beaches. One occurs along South Beach with significant feeder bluffs at the west end, while the other small drift cell is associated with the west side isthmus that connects Broken Point to the Shaw Island mainland. The other three drift cells occur in Blind Bay. One isolated cell occurs in the northwest end of the bay and terminates at a bedrock outcropping. The other two converge, as occurs in a classic pocket beach, at the head of Blind Bay.

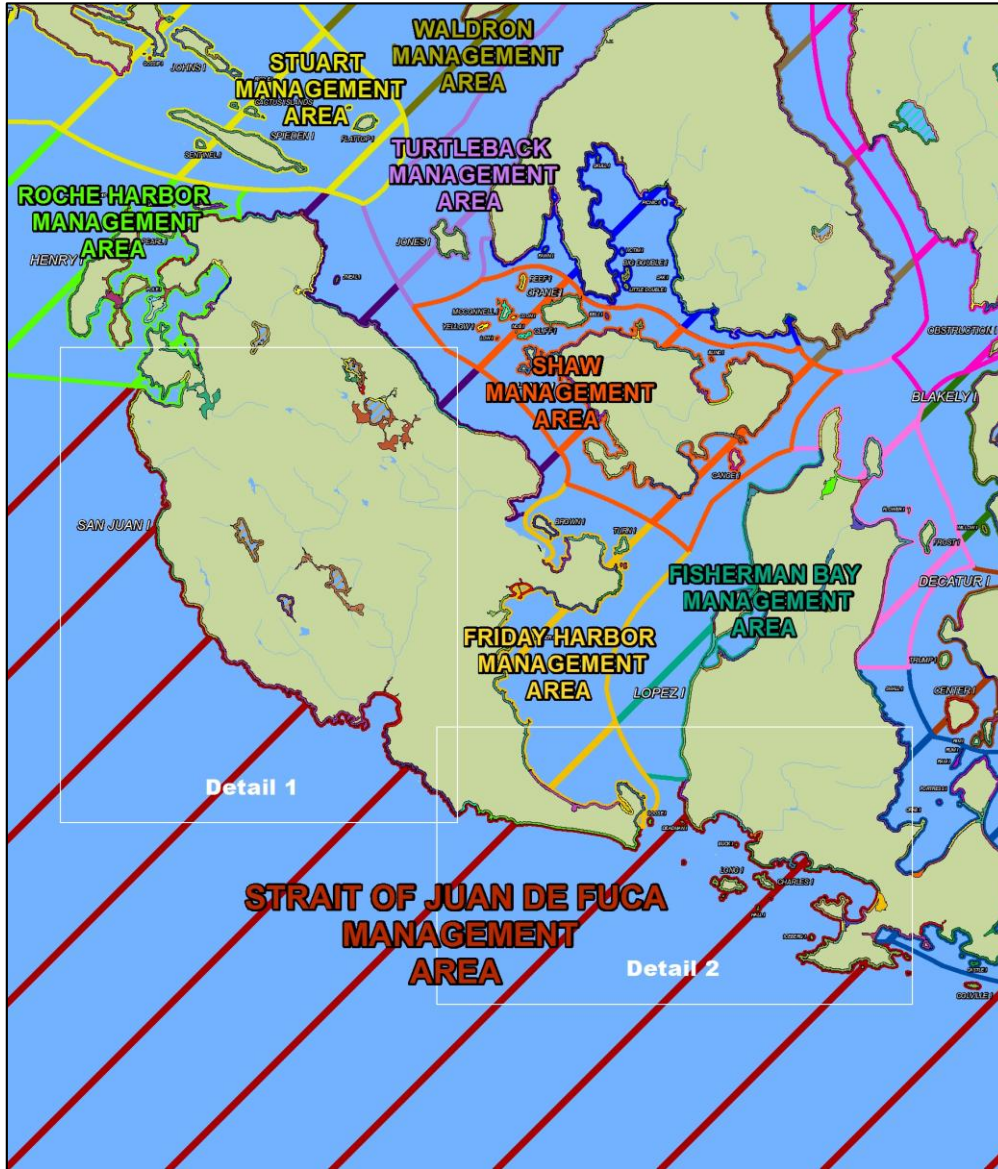
Figure 25. Strait of Juan de Fuca Management Area.

The Strait of Juan de Fuca management area is by far the largest management area in the County. It has over 57 miles of shoreline along the Strait of Juan de Fuca, primarily on southwest portion of Lopez Island and the southern shore of San Juan Island. It includes many rocky islets close to the San Juan and Lopez Island mainland, the largest of which are Charles Island and Long Island. It is bounded in the northwest by those shorelines that are protected by the Saanich Peninsula. To the southeast it is roughly divided where the shorelines become relatively protected by swell at the southeast end of Lopez Island. The management area is truncated on the southeast end of San Juan Island at Cattle Point, and it ends at the limit of bedrock on Lopez's western shore. There are no ~~major transportation facilities~~ [major transportation related uses](#) in this management area, although MacKaye Harbor Road does run adjacent to the shoreline for more than a mile on southwestern Lopez Island.
