RE: Shoreline Characterization Report for SMP Update/April 30, 2012

Parcel numbers: 261734004000 & 261734003000; West Sound Management Area;
Shoreline Reach No. 30

Narrative of Property for Shoreline Characterization/SMP Update —April 30, 2012
Property Owner: Vinton H. & Amelia J. Sommerville; Parcel numbers 261734004000 & 261734003000
West Sound Management Area—Shoreline Reach No. 30

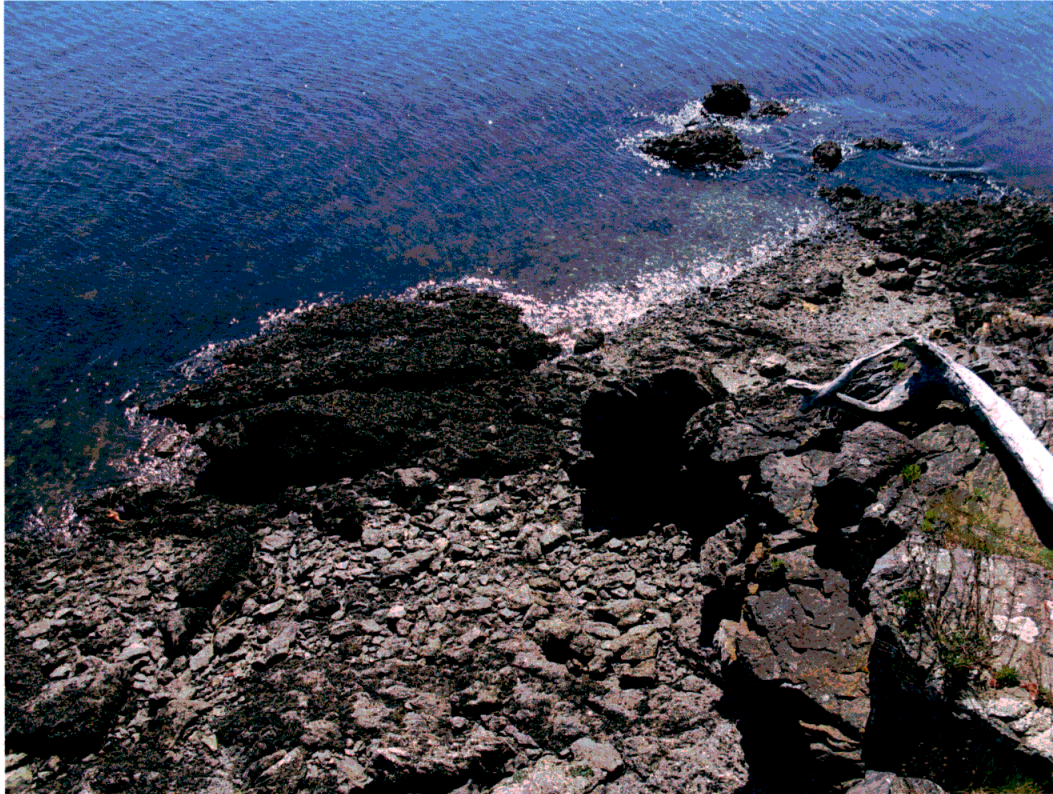
Shoreline at zero tide—very rocky substrate. This is not forage fish habitat. No eelgrass or bull-kelp present. Abundance of *Sargassum muticum* in shallows. No pocket beaches. (circa April 21, 2012).

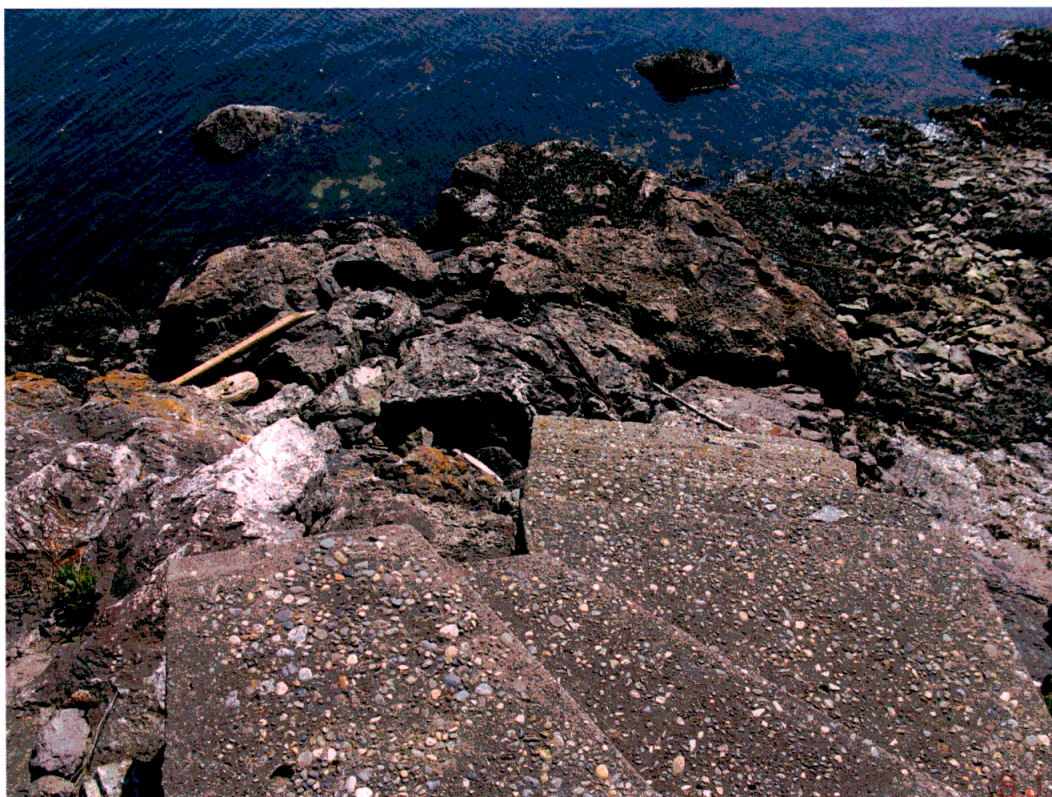
Shoreline at zero tide. Steps leading to beach. This is not forage fish habitat. No eelgrass or bull-kelp present. Very rocky substrate. No pocket beaches in ownership area of shoreline (circa April 21, 2012).

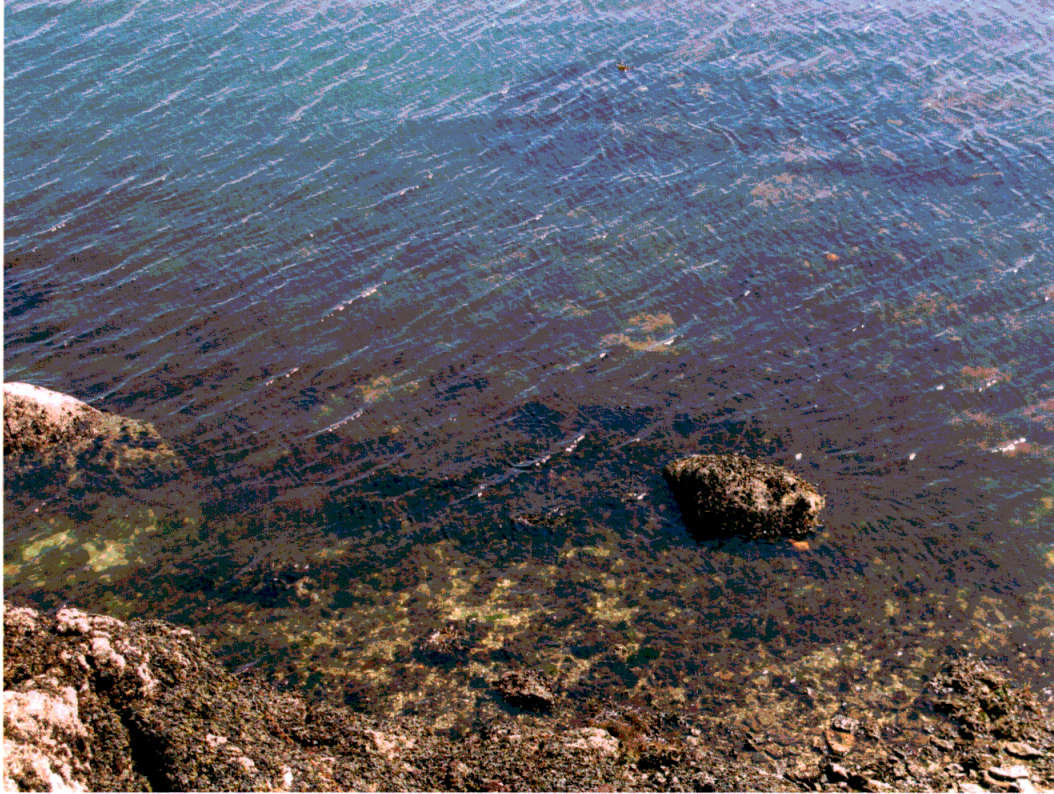
View of shoreline at zero tide. Shallows are inundated with *Sarcassum muticum*. No eelgrass or bull kelp present along shoreline of parcel. (circa April 21, 2012).

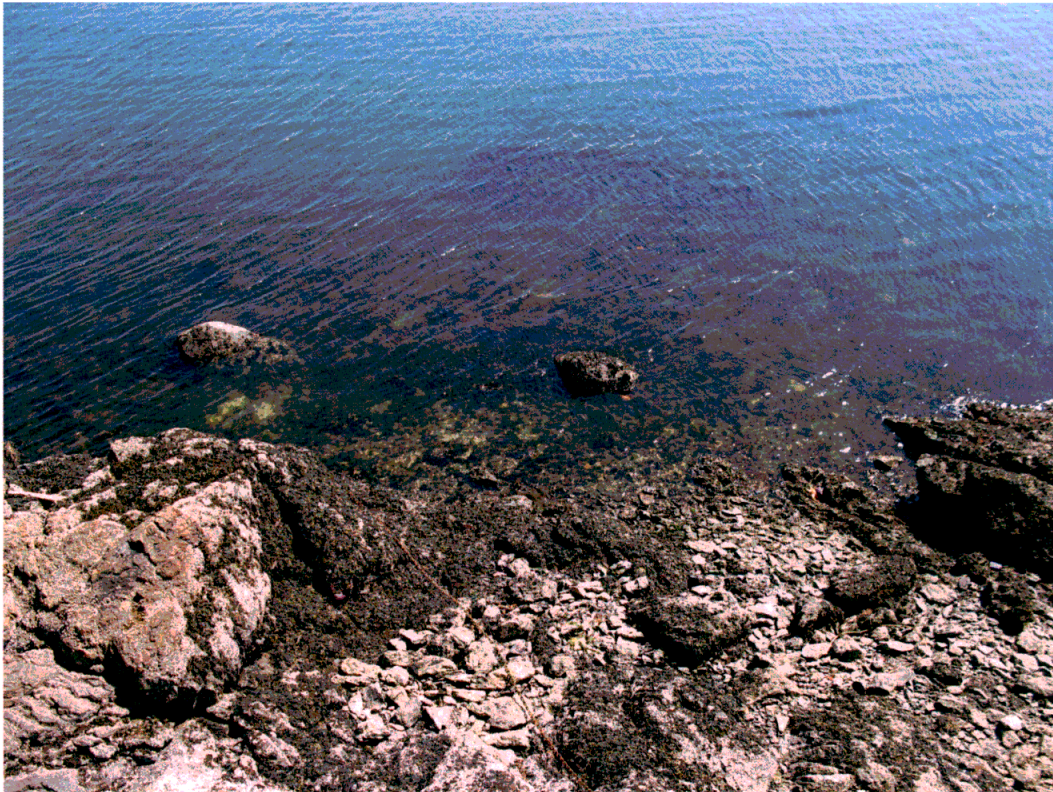
View of shoreline at zero tide. Shallows are inundated with *Sarcassum muticum*. No eelgrass or bull kelp present along shoreline of parcel. (circa April 21, 2012). This is not forage fish habitat.

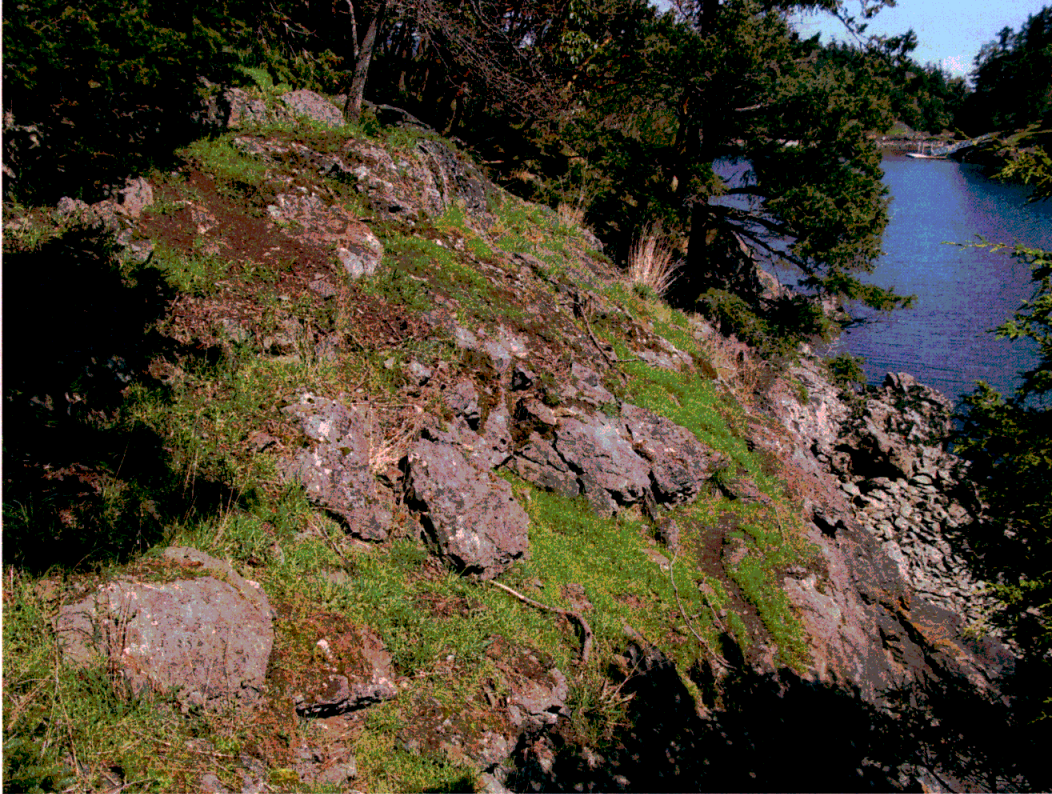
| Map 19 | Land cover | Palustrine emergent wetland indicated on map in area of home. <u>Impossible; not present.</u> Rocky coastline with Rocky Mountain Juniper present. No wetland species present. See photos attached |

View north from house towards reach boundary with reach 31. Garry Oak and Rocky Mountain Juniper species present. No evidence of palustrine emergent wetland as indicated on Map 19 (circa April 21, 2012).

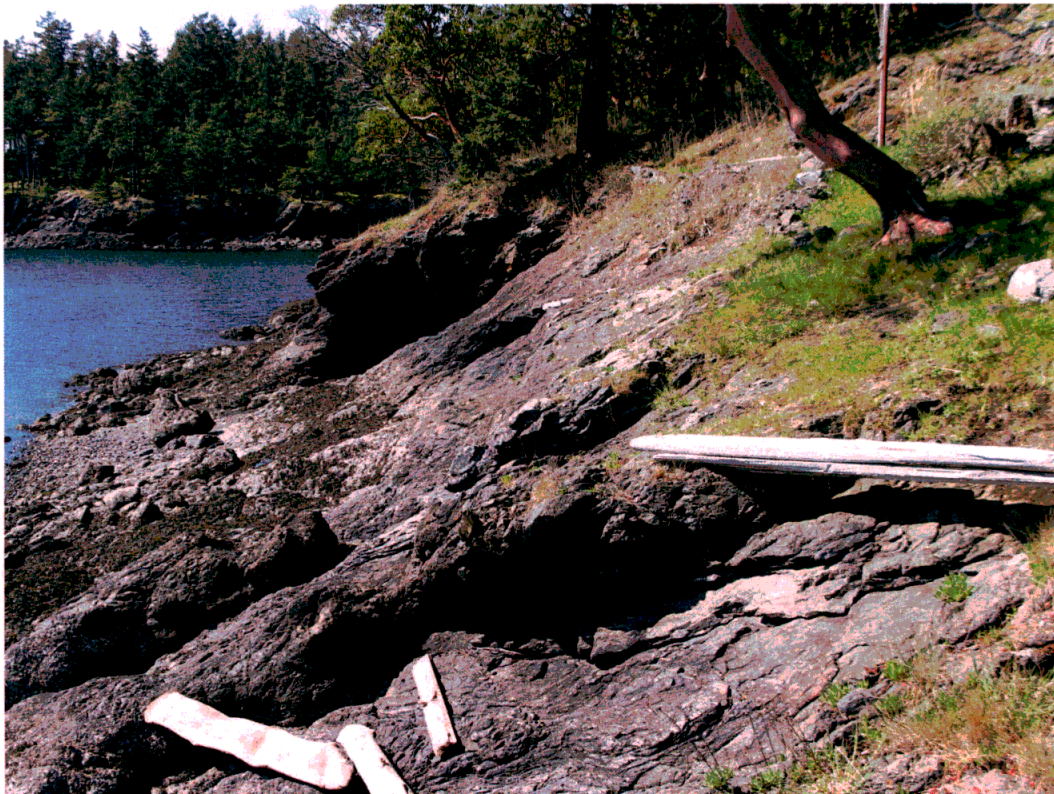
View west from house. No evidence of palustrine emergent wetland as indicated on Report Map 19 (circa April 21, 2012).
