San Juan County Courthouse

Seismic Evaluation

REPORT

April 15, 2022
WJE No. 2019.5417

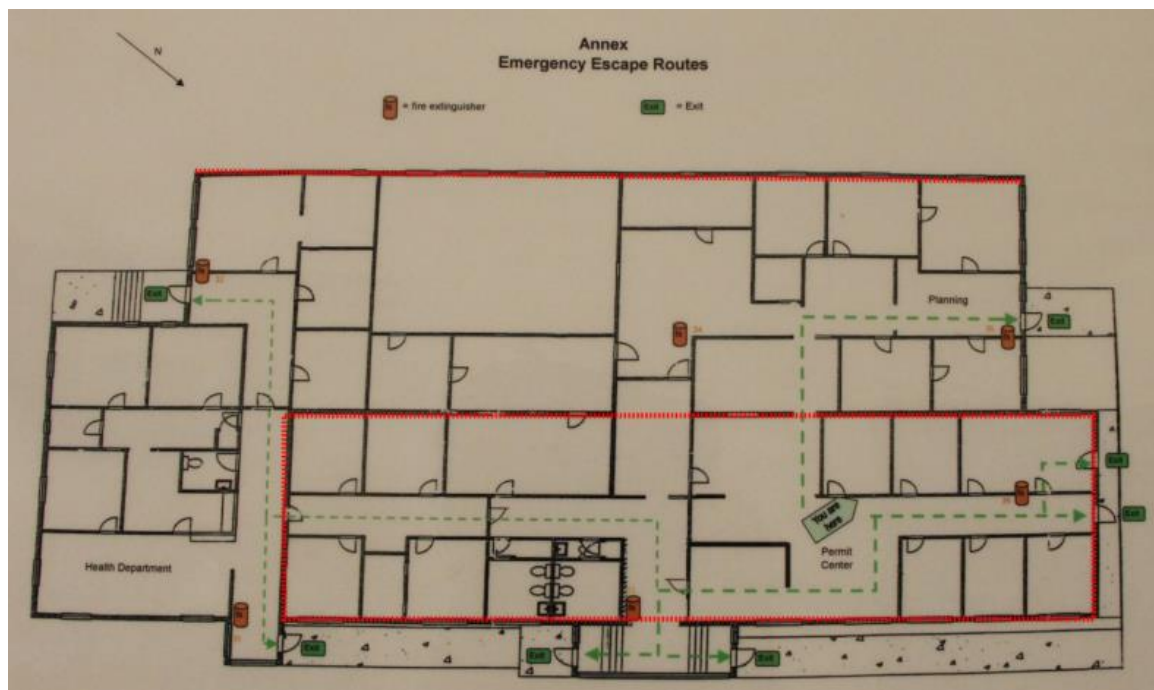
Figure 9. Courthouse Annex First Floor Plan. The red lines are annotated by WJE and indicate the location of CMU walls.

The buildings walls are light frame wood and CMU. Exterior wood-framed walls are sheathed with plywood siding. CMU wall locations are shown in Figure 9. The exterior walls and CMU walls are supported by concrete stem walls and strip footings at the foundation. The entire building is elevated above a crawl space. WJE observed 1/2-inch diameter anchor bolts at 48 inch spacing connecting the exterior wall sill plates to the concrete stem walls. Concrete stem walls at the interior of the building are unreinforced (Figure 28). The first floor is wood framed with 2x8 and 2x10 joists spanning between wood beams and/or the concrete stem walls. Wood beams are supported by 6x6 wood posts with concrete footings. The wood beams are typically connected to the posts with nailed plywood gussets (Figure 29), however in some cases, the beam just bears directly on the post with no side plates or steel connectors, or in other cases, a gusset is present on only one side of the connection. There are typically no mechanical connectors attaching the posts to the footings (Figure 29).

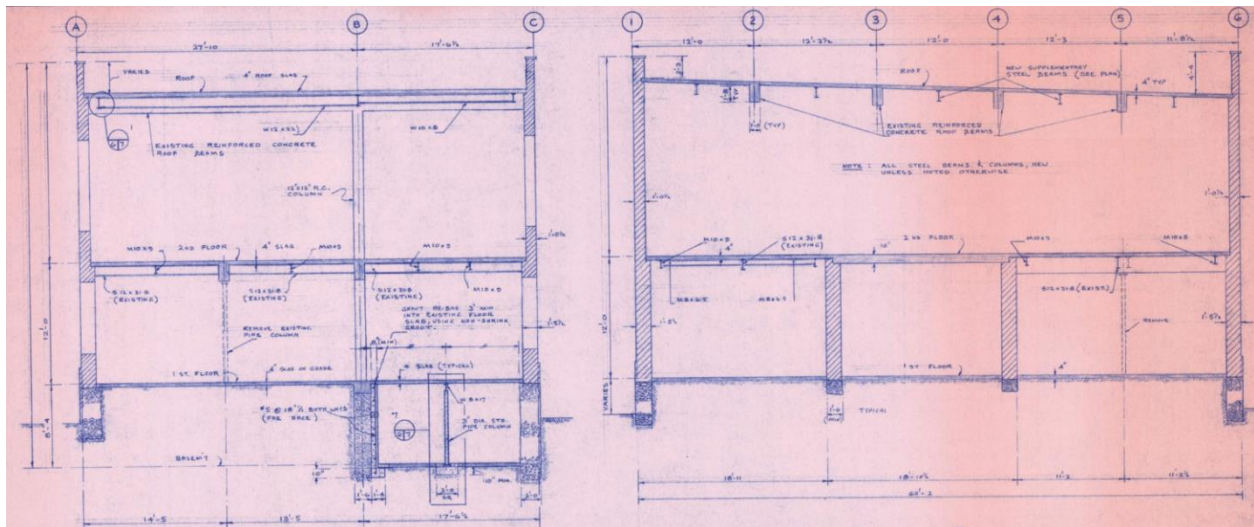
The structural notes on Sheet S-6 states that the governing code at the time of the remodel was the 1979 Uniform Building Code and the building is noted to be in Seismic Zone 3.

Figure 13. Building section of the original 1906 era courthouse building looking north (left) and looking west (right) from Sheet S-6 from the 1982 remodel drawings.

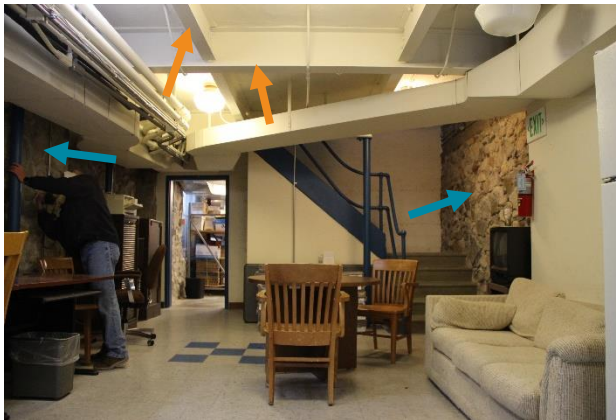
There is a partial basement below the first level on the east side of the building. Steel framing has been installed in the basement apparently to support the Level 1 concrete slab (Figure 19). The 1982 remodel drawings show the Level 1 concrete slab as four inches thick, however, GPR scanning demonstrated the concrete slab to be approximately 7-1/2 inches thick. The steel framing includes W10 beams spanning north-south between W12 beams, which are supported by steel posts at the perimeter of the basement. At the perimeter of the basement, the steel framing is connected to the concrete beam above the stone masonry exterior foundation walls with bolted connections (Figure 20). The presence of more modern steel framing suggests that the gravity load of the Level 1 slab is intended to be supported by the retrofit steel framing.

Figure 19. View of the Courthouse basement. Note the steel beams (orange arrows) supporting the floor above and stone walls (blue arrows) on the east and west sides of the basement.

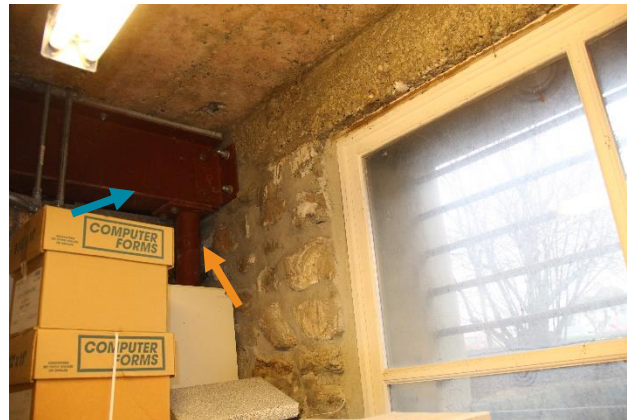
Figure 20. Steel beams (blue arrow) supporting the Level 1 slab are connected to the concrete beam above the stone masonry foundation walls in the basement. The steel beams are also supported by steel pipes (orange arrow) at the perimeter of the basement.

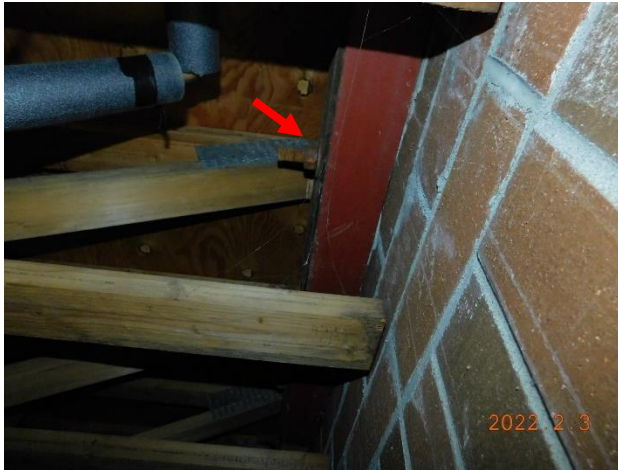
At approximately ten locations through the building, WJE removed drop ceiling finishes to observe as-built conditions of the structure which were otherwise obscured by finishes. At conditions along exterior walls, wood floor or roof framing was typically connected to wood ledgers which were anchored to exterior walls with 7/8-inch diameter anchor bolts that were typically spaced at 12 inches (Figure 22 and Figure 23). At one location at the roof above the Clerk's office; however, anchor bolts were spaced up to 22 inches. At the Superior Court high roof, there is an unsheathed wood pony wall which supports the high roof framing.

Figure 22. Typical floor framing-to-wall connection (Arrow indicates top chord bearing on ledger).

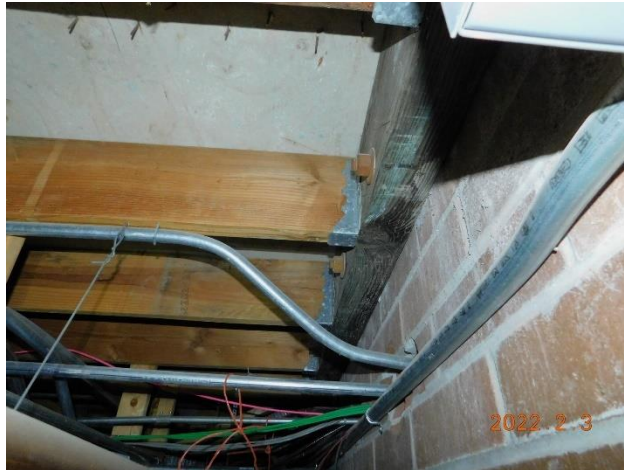
Figure 23. Typical floor framing-to-wall connection.

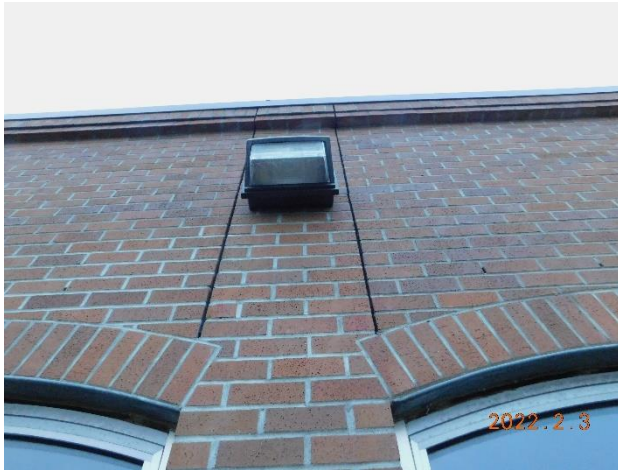
The Sheriff's Wing building appears to generally conform with the 1996 construction drawings as described in the *Document Review* section of this report. The exterior brick veneer walls include expansion joints that are open and weep holes at the base of the wall and above the windows (Figure 26). The ceiling is sheathed with gypsum board with limited access to observe the roof framing, which consists of pre-fabricated trusses with wood top and bottom chords and light gauge metal diagonal members (Figure 27).

Figure 26. Sheriff's Wing, expansion joints and weep holes in masonry veneer.

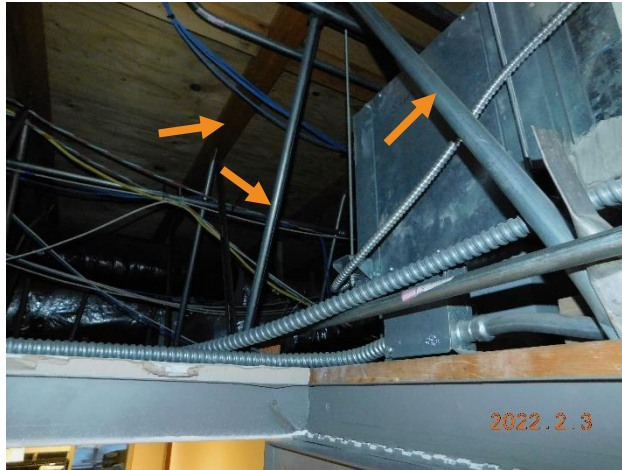
Figure 27. Sheriff's Wing, prefabricated roof truss (Arrows indicate top chord and diagonal members).
